## WATER ELECTROLYSIS SYSTEM REFURBISHMENT AND TESTING

**WATER ELECTROLYSIS SYSTEM**

**REFURBISHMENT AND TESTING**

Lockheed Missiles and Space Company, Inc.

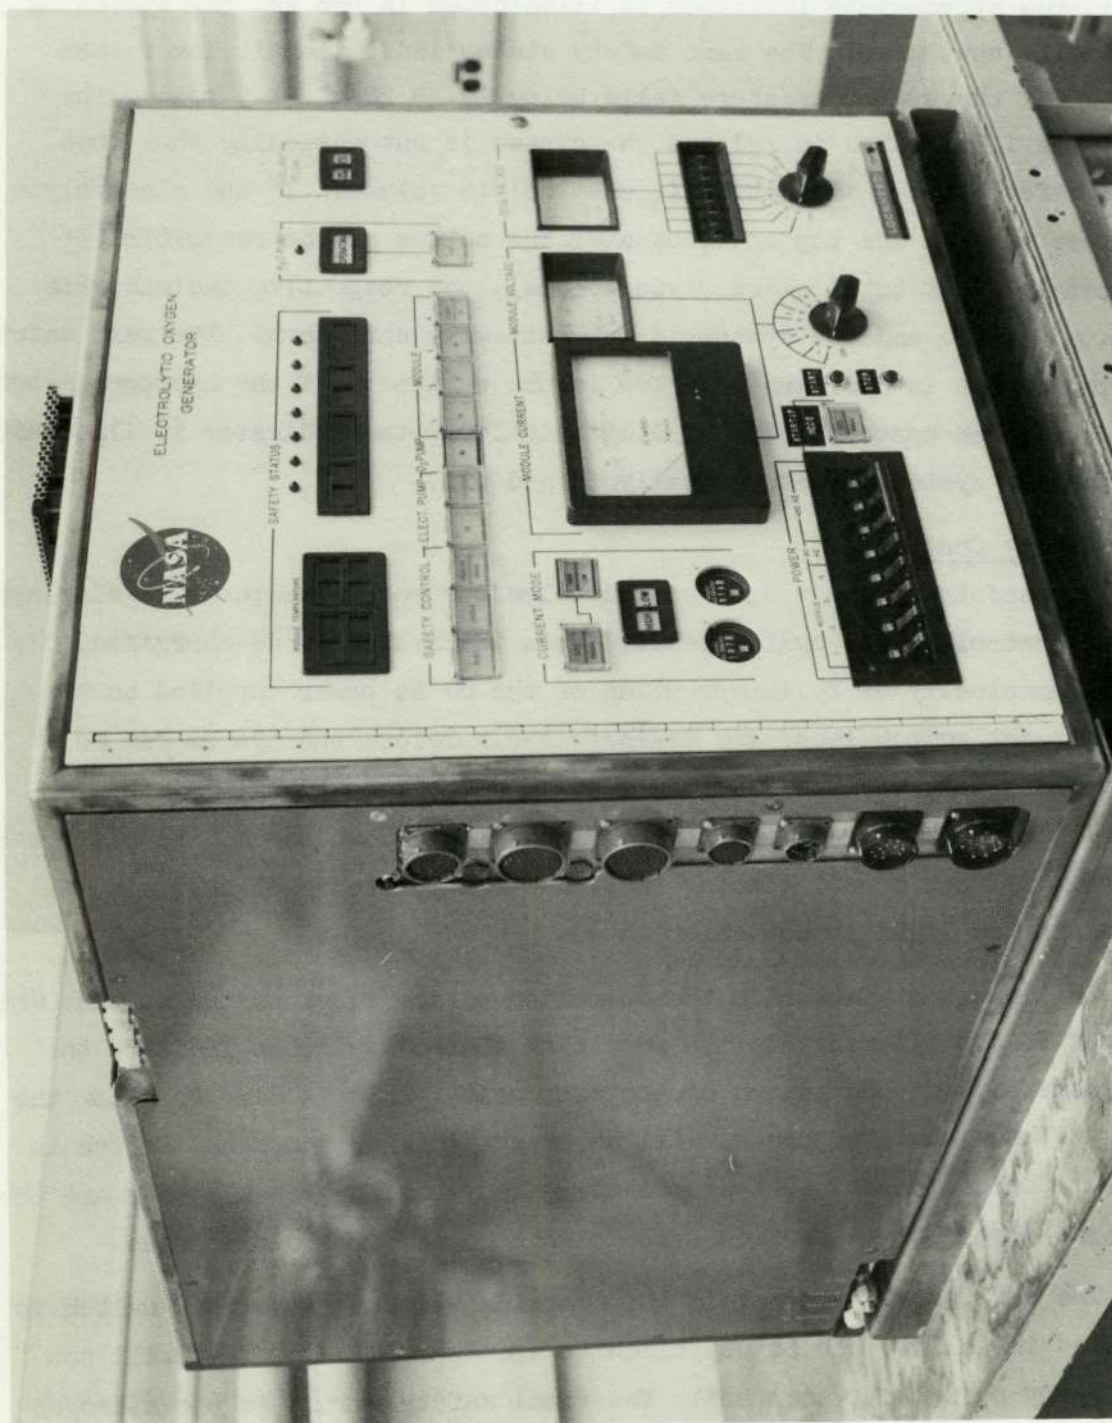
Figure 14 Front Panel Display and Controls

The controls and displays are provided into switches which are illuminated when the function is energized and not illuminated when the function is de-energized. Indicators are used to describe the status of some functions. The indicator and switch color codes are as follows: green indicates a normal condition; yellow indicates an abnormal condition or caution status; and red indicates an unsafe condition. During normal automatic operation, only green or non-illuminated switch lights should be visible.

The module temperature indicator displays two different temperature levels for each module. The first level indicated by a yellow lamp is  $30^{\circ}\text{C}$  ( $86^{\circ}\text{F}$ ). When this lamp is illuminated, the system is not shut down. This indicator serves only to warn of an impending over-temperature condition. The second temperature level is  $40^{\circ}\text{C}$  ( $104^{\circ}\text{F}$ ) and is indicated by a red light. If any of these indicators are illuminated, the system automatically shuts down.

The next safety status indication is excess hydrogen or oxygen gas pressure. If either gas pressure in the discharge manifold exceeds  $20.7 \text{ kN/m}^2$  (3 psig), the appropriate indicator is illuminated in red and the system is automatically shut down. The next safety status indication is low system pressure. If the system pressure falls below  $10.35 \text{ kN/m}^2$  (1.5 psig), the indicator is illuminated in red and the system is automatically shut down. The next safety status indication is electrolyte volume. If the electrolyte level rises to near the top or drops near the bottom of the reservoir (  $\pm$  approximately 3% of total electrolyte volume), the respective indicator is illuminated in red and the system is automatically shut down. The next safety status indication is hydrogen detected in the cabinet. If the hydrogen detector senses a hydrogen concentration of 0.8% by volume, the indicator is illuminated in red and the system is automatically turned off.

The safety controls are located below the module temperature displays. The first control is the system reset. When the system is de-energized, either automatically or by interruption of the 60 Hz power supplied to the unit, the reset switch lamps are de-energized. Before the system can be manually restarted, the reset switch must be depressed and illuminated in green. If the safety condition that caused the shutdown has not been corrected, the system will not reset. During initial startup, the reset must also be depressed if the light is not illuminated.
